Evaluation Level of Accessibility on Malioboro Pedestrian Way for People with Disabilities

Kurnia Nindya Nabila, Nursyamsu Hidayat

Civil Engineering Department, Vocational School, Gadjah Mada University,
Yogyakarta, Indonesia

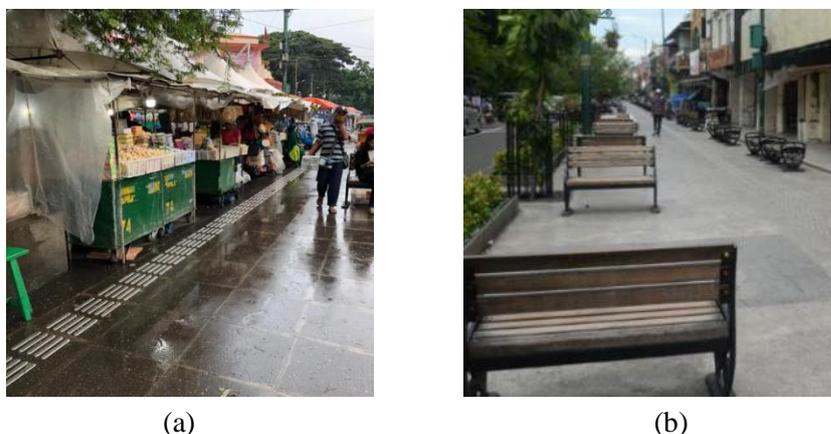
Figure 3. Pedestrian way, east side (a), west side (b)

The pedestrian way is made into 2 analyses, namely the east and west sides, there are 5 components that are used in terms of accessibility. Score for east side is 9 with a width of 10–12 m, making it very easy for people with disabilities to move freely without worrying about colliding with other visitors. Overall, the surface of pedestrian way is safe to use because the condition of the floor surface is quite stable, strong, not wavy and not slippery. Placement of street furniture in a safe location and does not interfere with pedestrian activities, but there are still street vendors who violate the rules by using pedestrian way at several points to sell using carts or stands, so that the width of the pedestrian way that should be passed by pedestrians becomes reduce.

The score of west side pedestrian way is 10 points, with a smaller width than the east side, which is 9 m, but visitors can move freely. The surface of the pedestrian way is quite stable, strong, not bumpy and not slippery at all locations. In addition, the placement of street furniture does not interfere with the comfort and safety of people with disabilities, and street vendors have used the places provided by the government to sell. The availability of seats is very adequate, with a distance of every 200 cm visitors can find seating facilities.

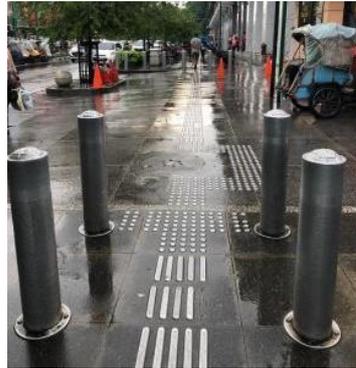
Figure 4. Guiding lane

Four components are used in the guideline accessibility requirements, and it get 4 points for scoring. Overall, the Malioboro area is equipped with guide lanes with stripes and round patterns, making it easier for people with disabilities, especially the blind. However, many of the warehouse blocks were damaged due to the hectic activity and frequent passing of street vendor carts and bicycles. The use of guiding block color is more dominant in silver than yellow which is only installed at certain points.

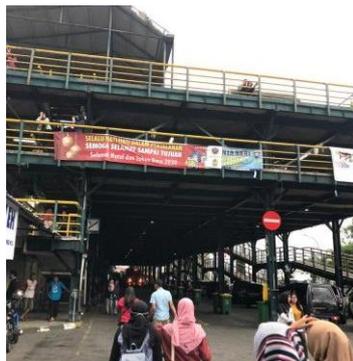
Figure 5. Abu Bakar Ali parking lots

Three components are used in terms of parking lot accessibility and it get 4 points. The closest distance needed from the Abu Bakar Ali Parking Special to the nearest Malioboro area, namely Hotel Inna Garuda Area, is 102 meters. This condition was not followed by the presence of special symbols for people with disabilities to facilitate accessibility, only symbols of orders, instructions, and prohibitions were found. The parking lot has sufficient area for people with disabilities, especially wheelchair users, to move safely and comfortably.

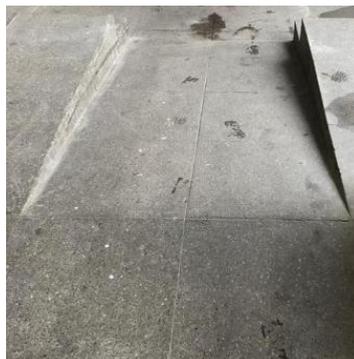
Figure 6. Ramp condition

Four components are used in the accessibility requirements of the ramp and the score is 7. The condition of the ramp has a slope of 7° and a ramp width of 100 cm without a safety edge, the condition of the ramp surface is not slippery, stable, strong and textured, but the condition of the end of the ramp is quite sharp which has the potential to be dangerous visitors. The ramp is equipped with the availability of sufficient lighting at every point.

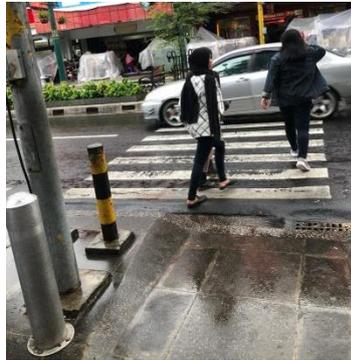
Figure 7. Zebra cross

Three components are used in the zebra cross accessibility requirements, it get 6 points. In Malioboro area, zebra crossings are available at several points to provide safety for pedestrians. A button to cross that is equipped with sound and visual is already available in the area, so that people with disabilities can move independently. At the end of the crossing area, both on the east and west sides, there are ramps.

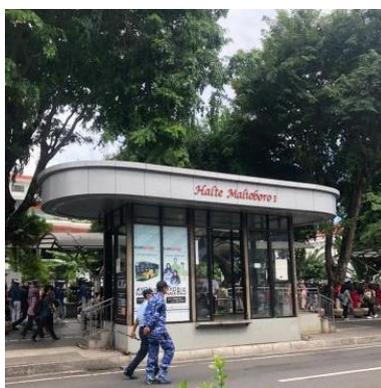
(a)

Three bus stops exist in Malioboro, then called Bus Stop 1, Bus Stop 2, and Bus Stop 3. There are 3 components used in terms of accessibility. Bus Stop 1 located in front of the Inna Garuda Area Hotel got 4 points, where the condition of the stop is that stairs and ramp facilities are equipped with handrails. Notification of information is still manually using the help of the bus stop staff. The availability of seats is not proportional to the number of Trans Jogja users, there is only 1 seat with a capacity of 3 people, so many prospective passengers are standing while waiting for the arrival of Trans Jogja.

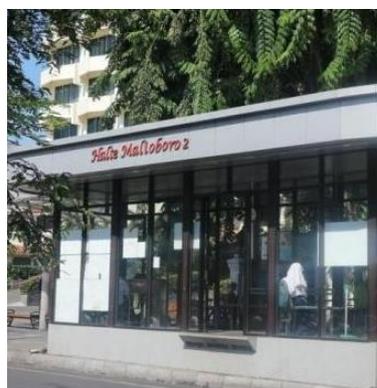
(b)

Bus Stop 2 located in front of Mutiara Hotel got 5 points, the availability of stairs and ramp facilities that are equipped with handrails, making it easier for people with disabilities to access the bus stop independently or with the help of others. Bus stop officers are available to provide information on routes, bus arrivals and manually purchase Trans Jogja tickets. The availability of seats is more than the Bus Stop 1, which is 3 seats with a capacity of 9 people.

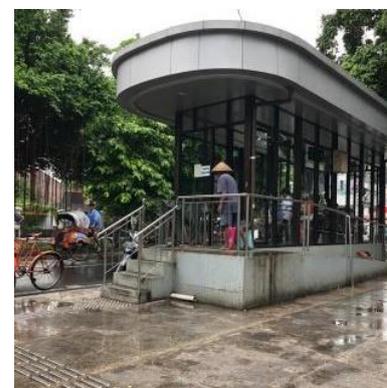
(c)

Bus Stop 3 located in front of the Vredeborg Fort Museum got 5 points, the condition of the bus stop is that there are stairs and ramps equipped with handrails that make it easier for people with disabilities, especially wheelchair users or people who push the wheelchair to access the entrance and exit of the bus stop. Providing information on arrivals, routes and purchasing Trans Jogja tickets, assisted by bus stop officers, for the availability of very adequate seats, namely 4 seats with a capacity of 12 people.

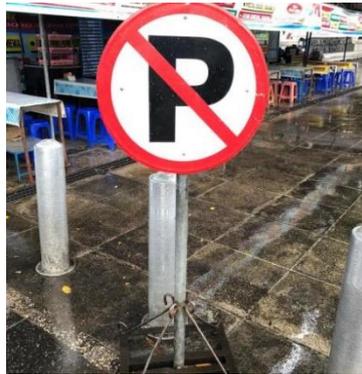
Figure 9. Sign and marking

Three components are used in terms of accessibility of signs and markings, with 4 points of scoring. There are no signs and markings in braille that are specifically for the disabled. The signs available at these locations in the form of prohibition signs, command signs, and general guidance signs in locations that are free of sight without any barriers and have used international symbols, so that they are easily understood by local and foreign tourists when visiting. However, there are some signs that are starting to fade, making it difficult to read in long distances.

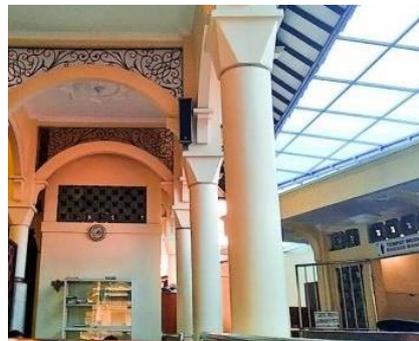
Figure 10. Worship place

Four components are used in terms of accessibility of places of worship, it gets 8 points. The availability of places of worship in this area is quite good and the location is strategic. Places of worship for men and women are separate, equipped with adequate worship facilities. The condition of the ablution place both in terms of lighting and floor texture is quite good, namely lighting from sunlight during the day and lighting at night and the floor texture is not slippery, so it does not interfere with worship activities.

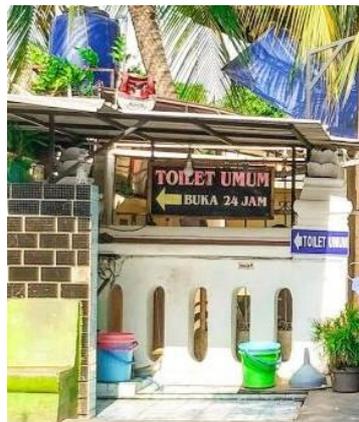
Figure 11. Toilet

Four components are used in the accessibility requirements of public toilets, it get 5 points. Throughout the survey area, only toilets for the general public were found, there were no special toilets for people with disabilities. The toilet measures 175 cm x 250 cm with a door that can be opened both inside and out. The handrail that serves to facilitate movement of the disabled in the room is only found in one toilet cubicle.
